**Re: City of Las Cruces, East Mesa Water Reclamation Plant; Major; Individual Permit; SIC 4952;
Compliance Evaluation Inspection; NPDES Permit NM0030872; February 14, 2019**

NPDES Compliance Inspection Report

Further Explanations
City of Las Cruces, East Mesa Water Reclamation Facility
Compliance Evaluation Inspection
NPDES Permit No. NM0030872
Inspection Date: February 14, 2019

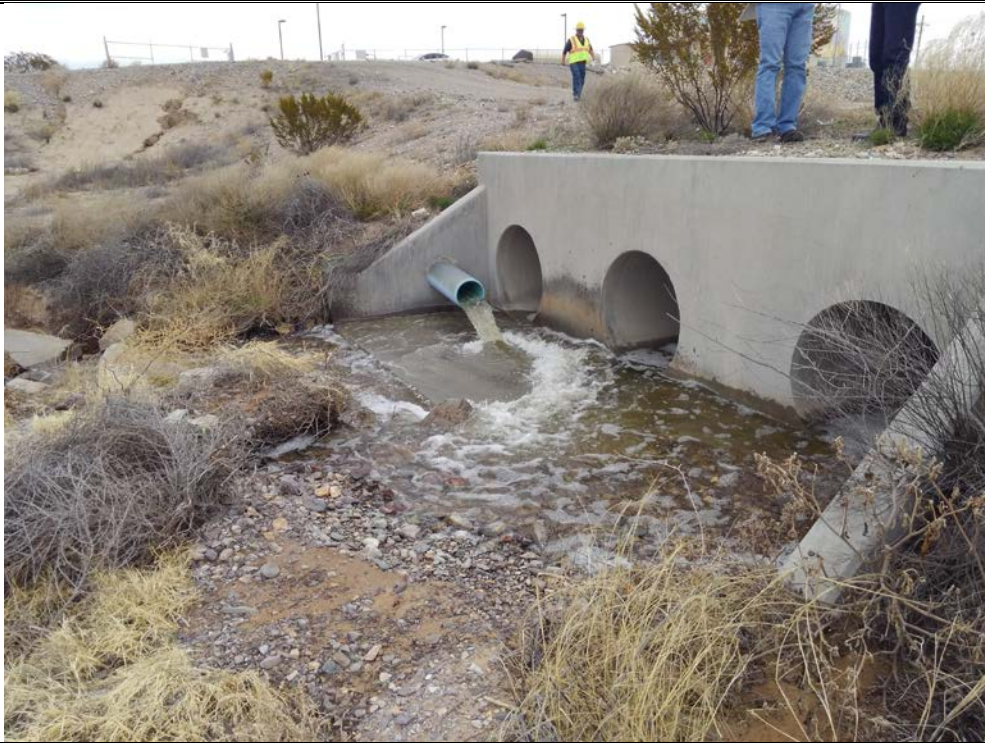
**NMED/SWQB
Official Photograph Log
Photo # 2**

RECEIVING WATER OBSERVATIONS
Photo 2. Facility is preparing a TRE Action Plan.**SECTION H - SLUDGE DISPOSAL**SLUDGE DISPOSAL MEETS PERMIT REQUIREMENTS. ☒ S ☐ M ☐ U ☐ NA (FURTHER EXPLANATION ATTACHED NO).
DETAILS: Sent to Jacob Hands WWTP1. SLUDGE MANAGEMENT ADEQUATE TO MAINTAIN EFFLUENT QUALITY. ☒ S ☐ M ☐ U ☐ NA2. SLUDGE RECORDS MAINTAINED AS REQUIRED BY 40 CFR 503. ☒ S ☐ M ☐ U ☐ NA3. FOR LAND APPLIED SLUDGE, TYPE OF LAND APPLIED TO: N/A (e.g., FOREST, AGRICULTURAL, PUBLIC CONTACT SITE)**SECTION I - SAMPLING INSPECTION PROCEDURES** (FURTHER EXPLANATION ATTACHED ___).1. SAMPLES OBTAINED THIS INSPECTION. ☐ Y ☐ N ☒ NA

Subject: Effluent at discharge point

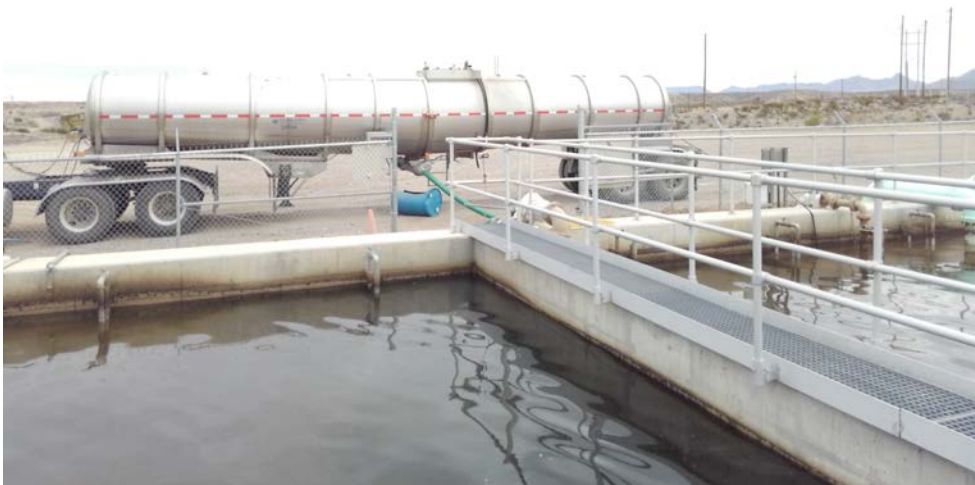
**NMED/SWQB
Official Photograph Log
Photo # 3**

Subject: pumping sludge with spill container at fill port
